Orbit Newsletter Digital Publication

Q1 2022

Vibration issue on Compressor in a Nitric Acid Plant

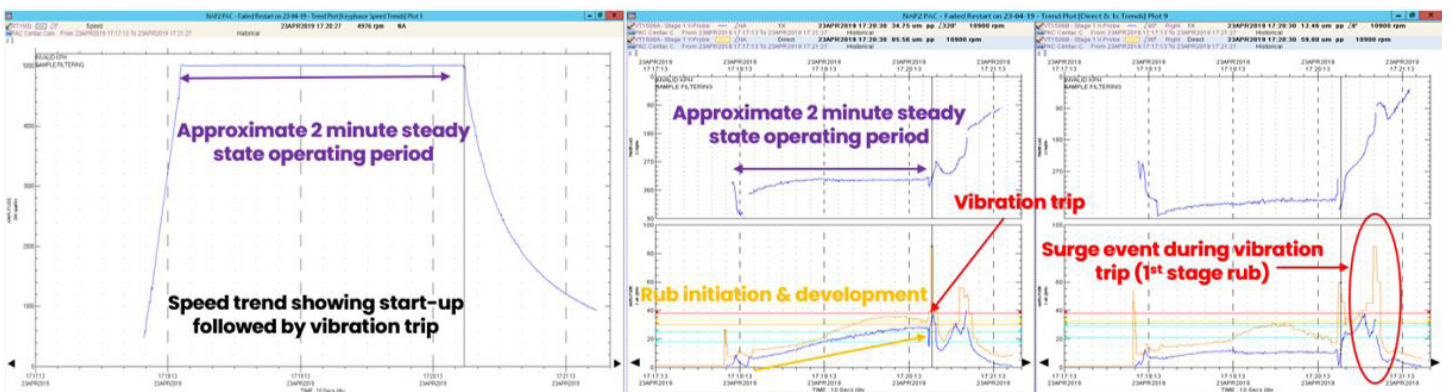
On April 23rd, 2019 the NAP2 plant was shut down due to a plant process related issue. The plant operators then attempted an immediate restart. Approximately two minutes post the re-start @ 17:20:27 the OEM Danger (Severity 4) trip set-point was breached and the unit tripped off-line on high 1st stage direct vibration. Review of the trip data indicated a 1st stage rub had initiated the vibration related trip. During the shutdown vibration related trip event, the compressor 1st stage experienced rotating stall/surge related issues at approx. 11,350 rpm and between approx. 5,600 & 4,300 rpm (See Figure 2). These stall/surge related issues associated with the anti-surge system (inlet guide vane IGV and timing/control related issues). See figure The direct/1x synchronous trends and direct orbit/timebase plots indicate the significant sub-synchronous (0.53x) vibration associated with compressor 1st stage stall/surge issues during the April 23rd, 2019 shutdown. Compressor 1st stage Bode plots show increased not-1x vibration (GREEN line) during the April 23rd, 2019 shutdown transient event (BLUE & ORANGE lines are 2017 reference data), as shown in Figure 3. 2 over-leaf.

Figure 2: Rub and stall/surge events initiated immediately after reaching full speed

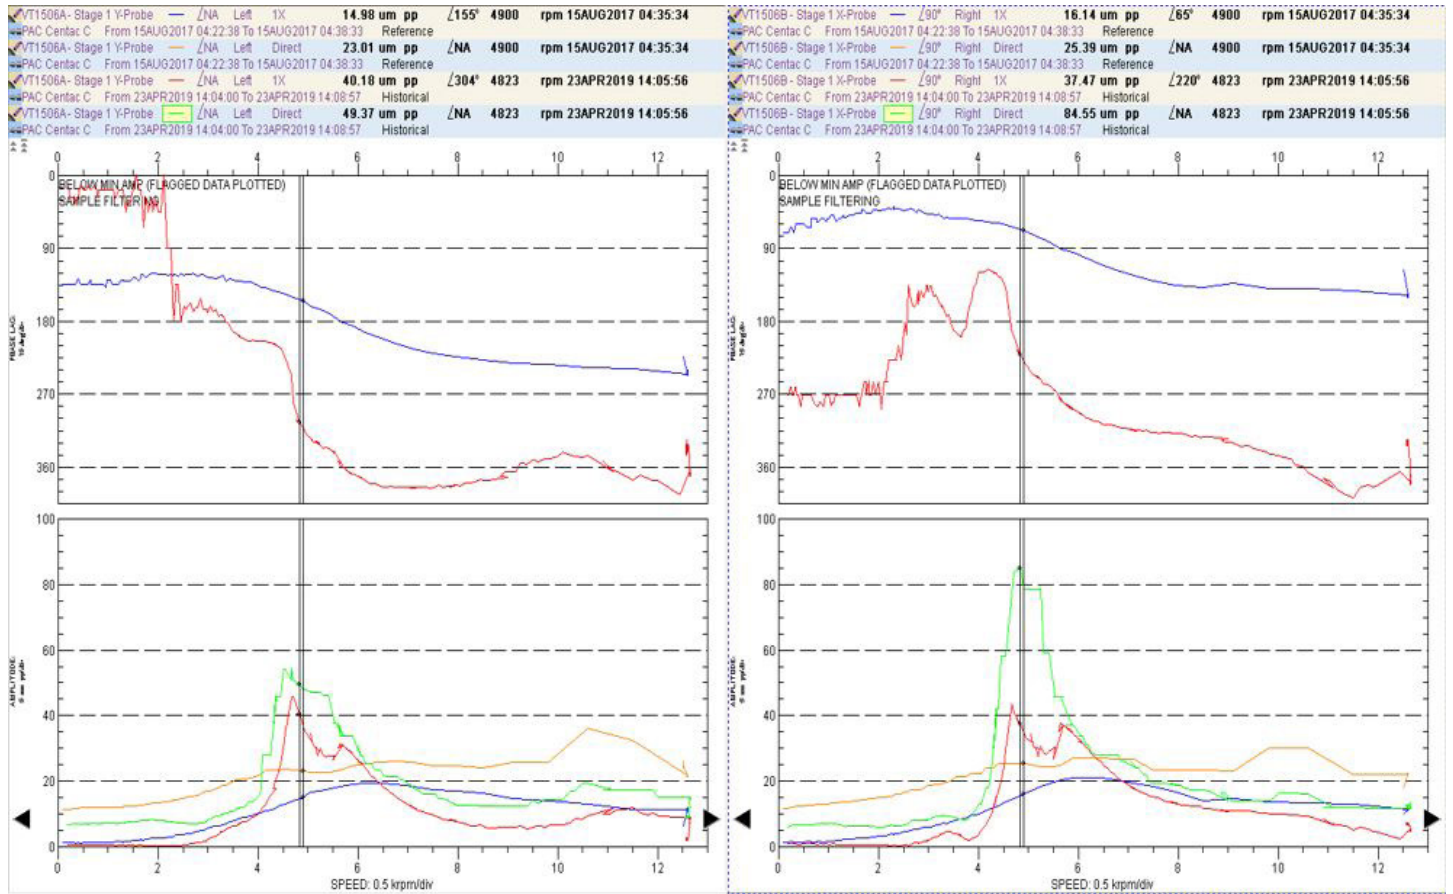
The direct/1x synchronous trends and direct orbit/timebase plots indicate the significant sub-synchronous (0.53x) vibration associated with compressor 1st stage stall/surge issues during the April 23rd, 2019 shutdown. Compressor 1st stage Bode plots show increased not-1x vibration (GREEN line) during the April 23rd, 2019 shutdown transient event (BLUE & ORANGE lines are 2017 reference data), as shown in Figure 3.

Figure 3: Bode plots. Compressor 1st stage stall/surge related issues during the April 23rd, 2019 shutdown transient event overlayed with historical reference data

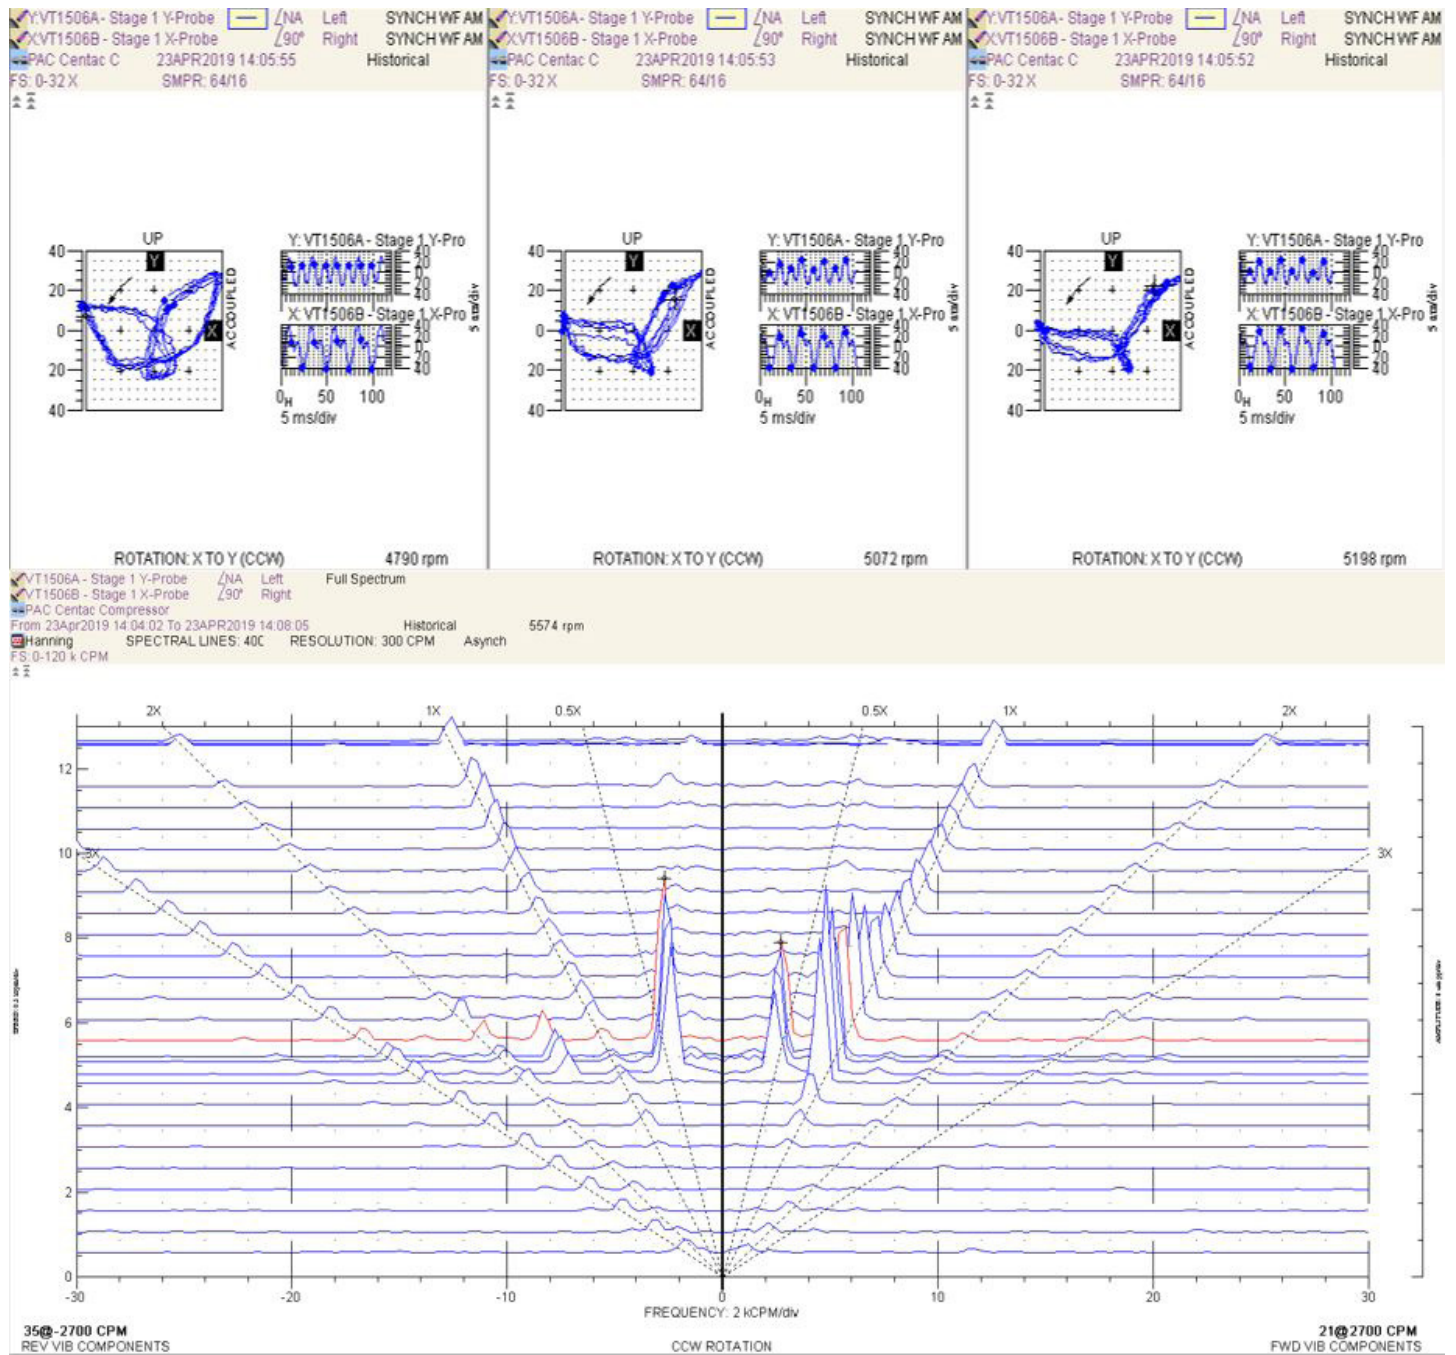
The significant compressor 1st stage sub-synchronous vibration (35 μm pp @ $-0.53x$ & 21 μm pp @ $0.53x$ @ 2,700 rpm) measured during the April 23rd, 2019 shutdown (vibration trip) transient event is demonstrated in the full spectrum asynchronous cascade plots as shown in Figure 4

Figure 4: Orbits and full spectrum cascade plot. Significant sub-synchronous (0.53x) vibration associated with the compressor 1st stage stall/surge issues

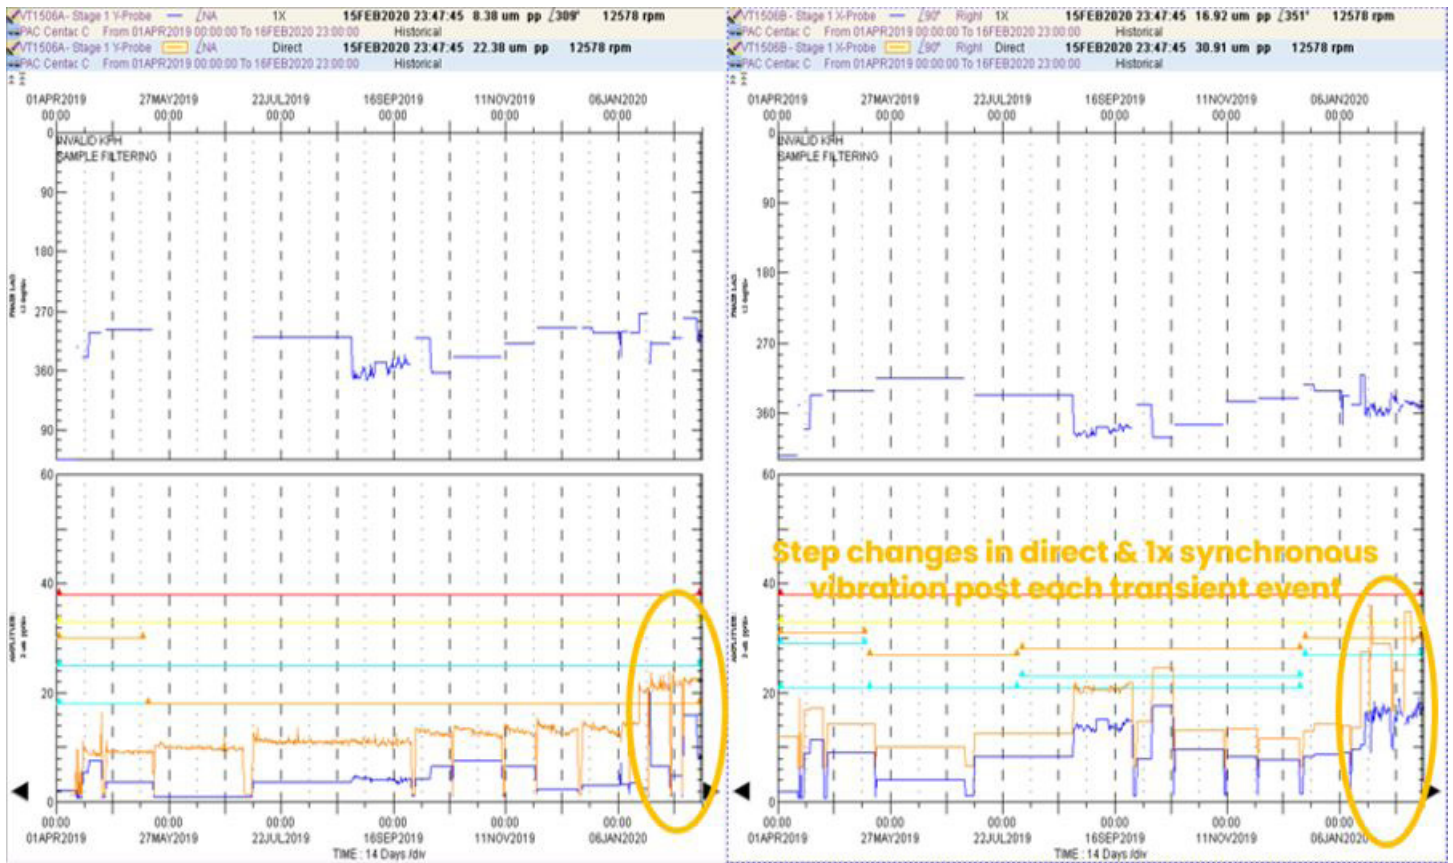
The compressor 1st stage direct & 1x synchronous long-term trend plots verify a series of step changes in direct values post each shutdown transient event associated with increasing -3X reverse component vibration with amplitudes as high as 14 um pp measured on February 6th, 2020. 1X synchronous trended values were also noted as being variable post each shutdown transient event as well as during steady state operation.

Direct values became highly variable in January 2020 breaching the OEM Alert value of 33 um pp, but remaining marginally below the Danger (trip) set-point of 38 um pp.

Figure 5: Trend plots. Series of step changes in compressor 1st stage direct values post each shutdown transient event

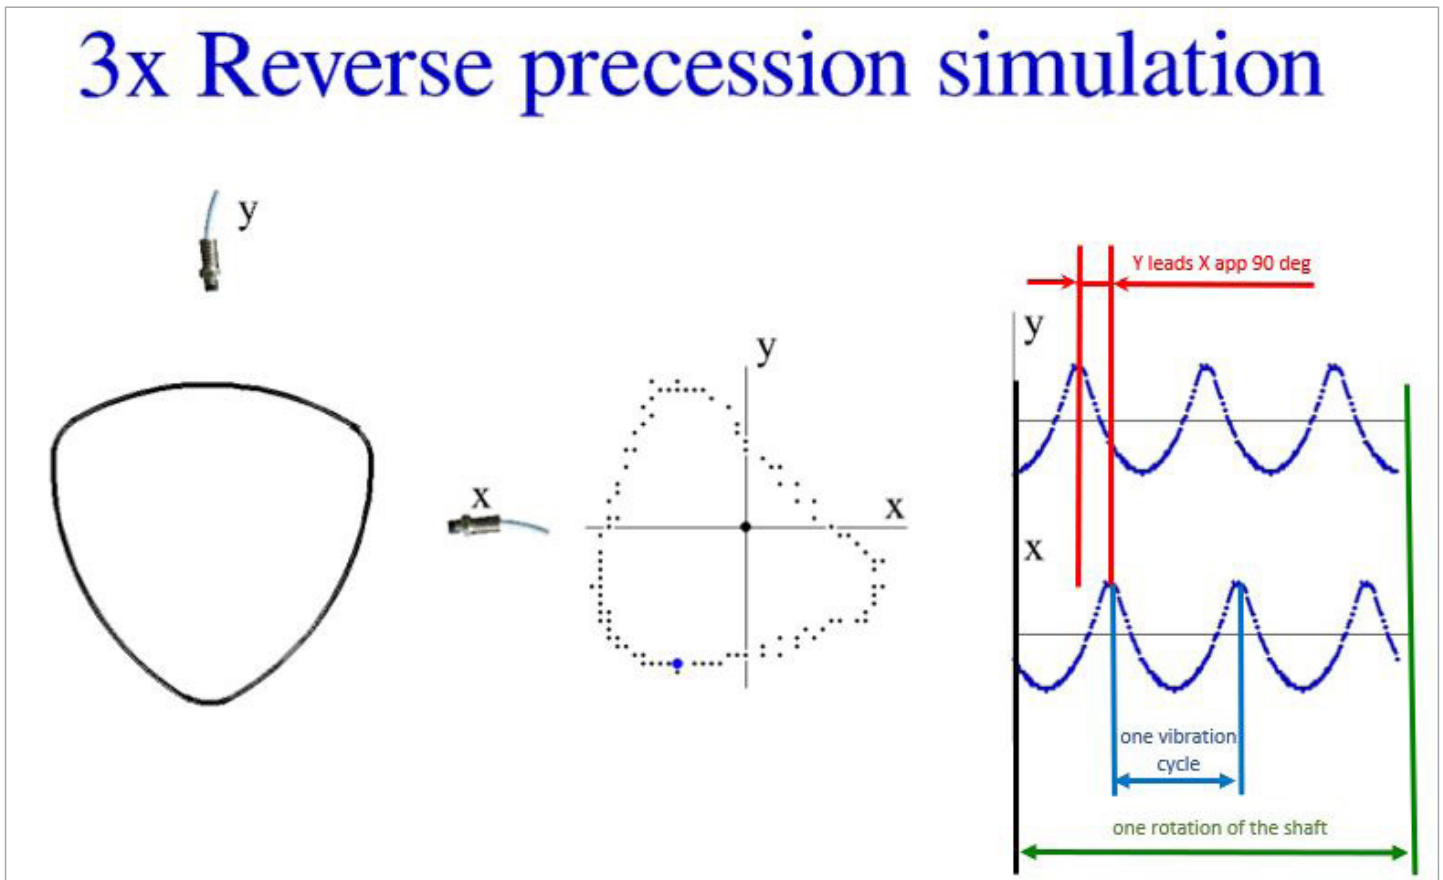
The polygon (journal) direction of rotation is CCW, at the same time the direction of the XY waveforms based orbit precession is CW. There is clear evidence of -3X reverse precession component presence - the direction of the shaft rotation is from X to Y probe, with the Y probe waveform is leading by 90 degrees, as shown in Figure 6.

Figure 6: Run-out simulator. Evidence of -3X reverse precession component for given CCW shaft direction of shaft rotation

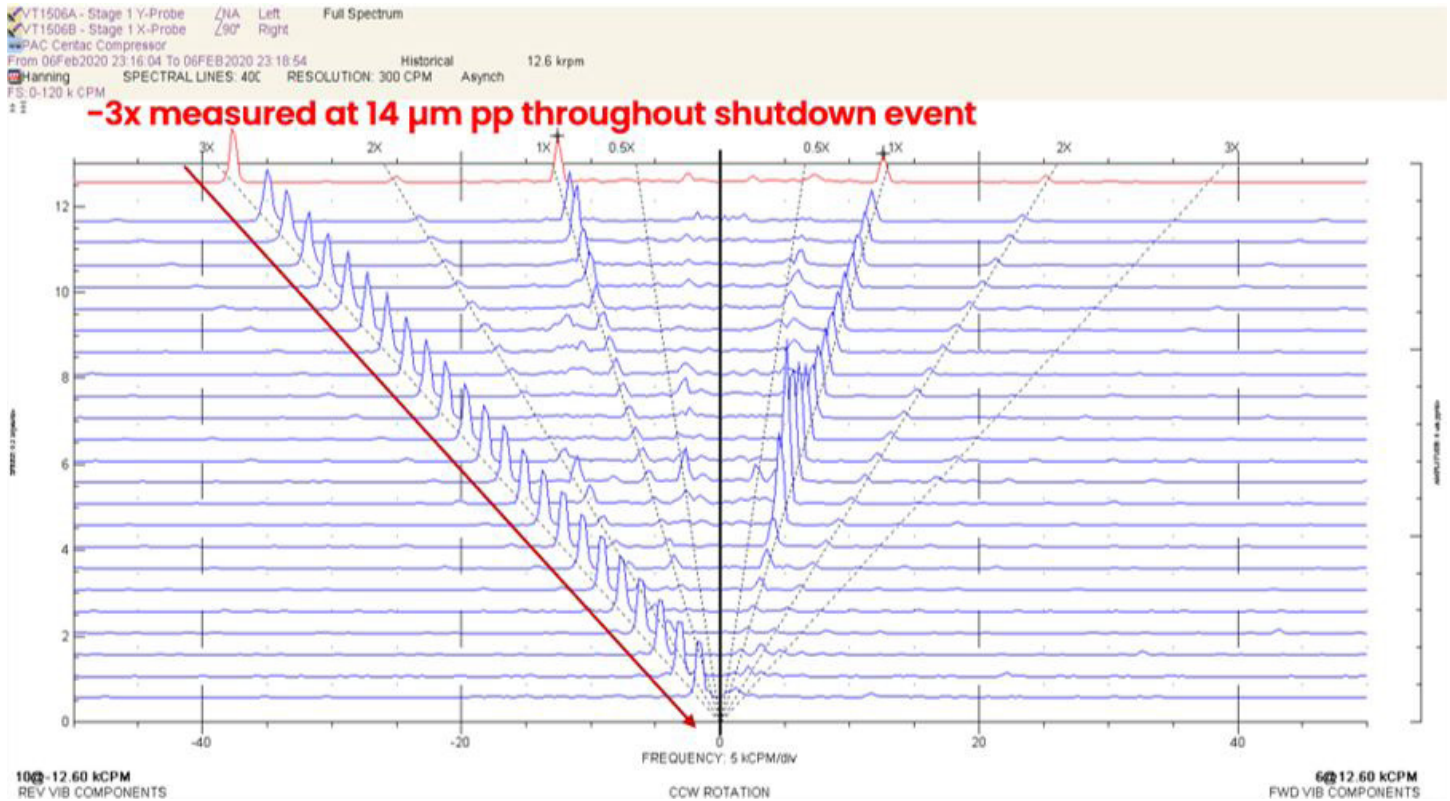
The February 6th, 2020 shutdown was the last shutdown transient event prior to the OEM site-based repair at the end of that month. The Compressor 1st stage full spectrum cascade plot indicates -3X reverse component vibration measured in the region of 14 μm pp throughout the Feb 6th, 2020 shutdown. 1x synchronous reverse vibration amplitudes are also higher than the forward components, the exception being as the rotor transitioned the 1st (translational) critical speed range.

The -3X reverse component indicated a compromised fit between the impeller bore and the rotor journal (tapered polygon P3 design) resulting in journal deflection during steady state and transient operation, as shown in Figure 7.

Figure 7: The Compressor 1st stage full spectrum cascade plot indicates -3X reverse component

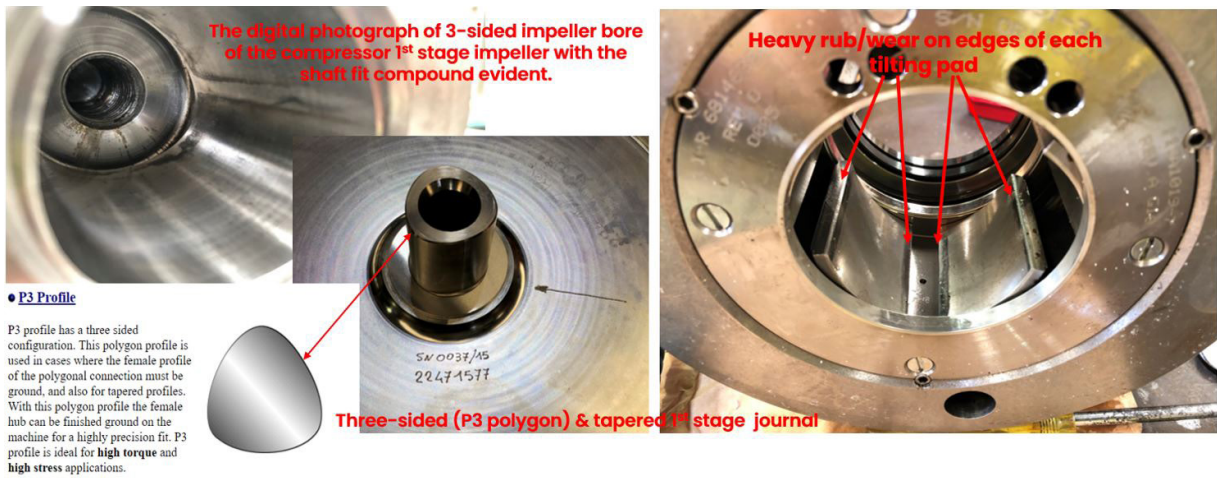
Figure 8: Maintenance Findings

- 1st stage tilting pad bearing indicated signs of heavy rub on the bottom two pad edges.
- 1st stage cylindrical bearing indicated signs of rub at the top of the bearing and heavier at one end.
- 1st stage impeller bore indicated evidence of anti-seize/slip compound used during the impeller installation at the OEM factory in Italy.
- 1st stage tilting pad bearing replaced.
- 1st stage cylindrical (outboard) bearing replaced.
- 1st stage impeller was slow-speed balanced (dedicated shop balancing machine - in a low-speed balancing machine).

Bently Nevada was informed of the following OEM off-site root cause analysis findings (nearly 12 months post the site visit), 1st stage tilting pad & cylindrical bearings were supplied with incorrect dimensions, radial bearing clearances are not checked by OEM prior to installation (mandrel checks) with only the thrust bearing end float checked/verified.

The shop balanced original impeller was re-installed onto the 1st stage rotor journal as per OEM specifications with no anti-seize/slip compound applied.

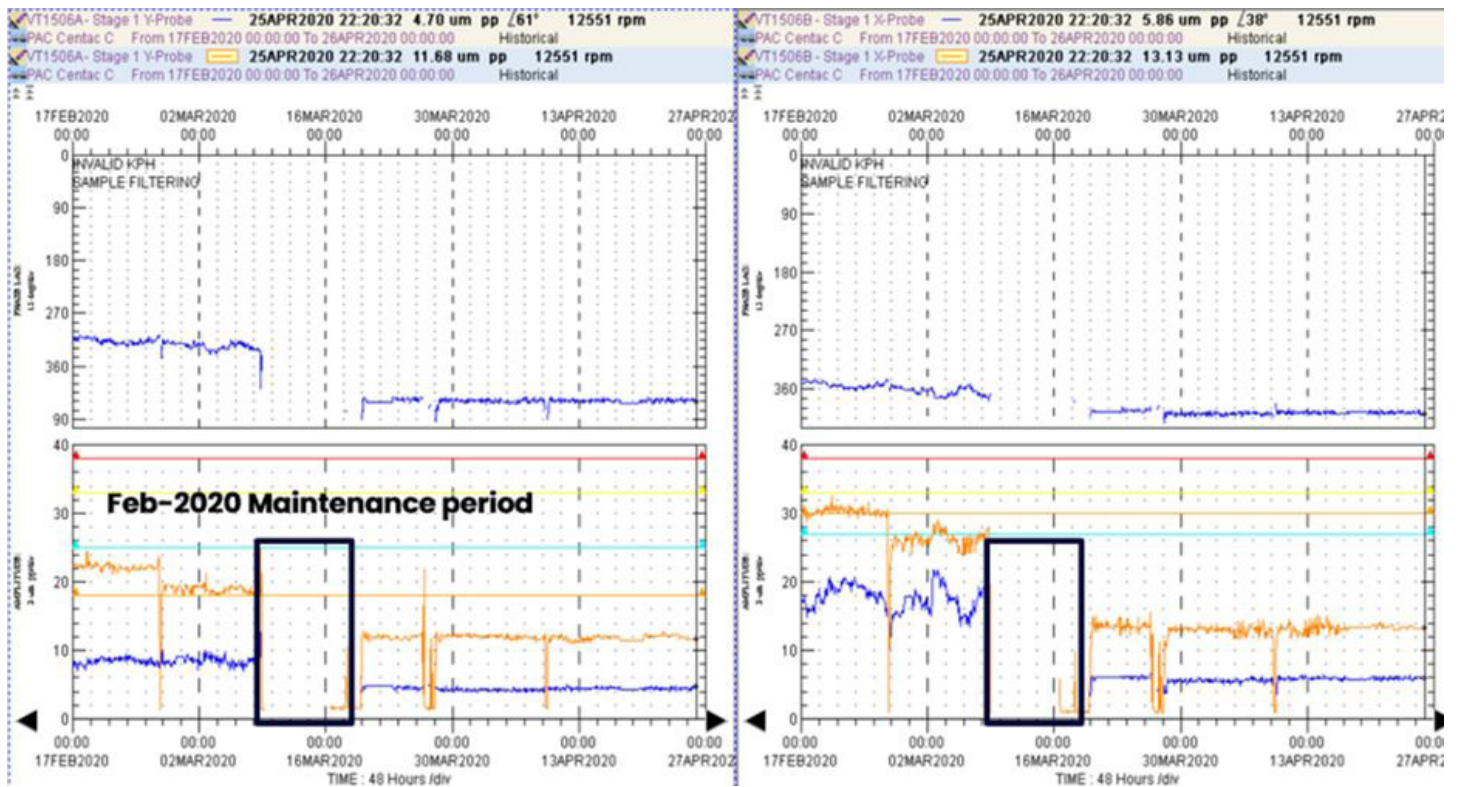
Post the repair there was a step decrease in compressor 1st stage direct & 1x synchronous values with direct values now trending well below the OEM Alert set-point of 33 μm , figure 9.

The decrease in compressor 1st stage direct values is attributed to decreases in the amplitudes of the previously dominant 1x & -3x 1st stage frequencies (12,558 rpm rotor). See Figure 9 for direct & 1x synchronous trends.

Figure 9: Compressor 1st stage direct and 1X trend plots. Post-maintenance improvement.

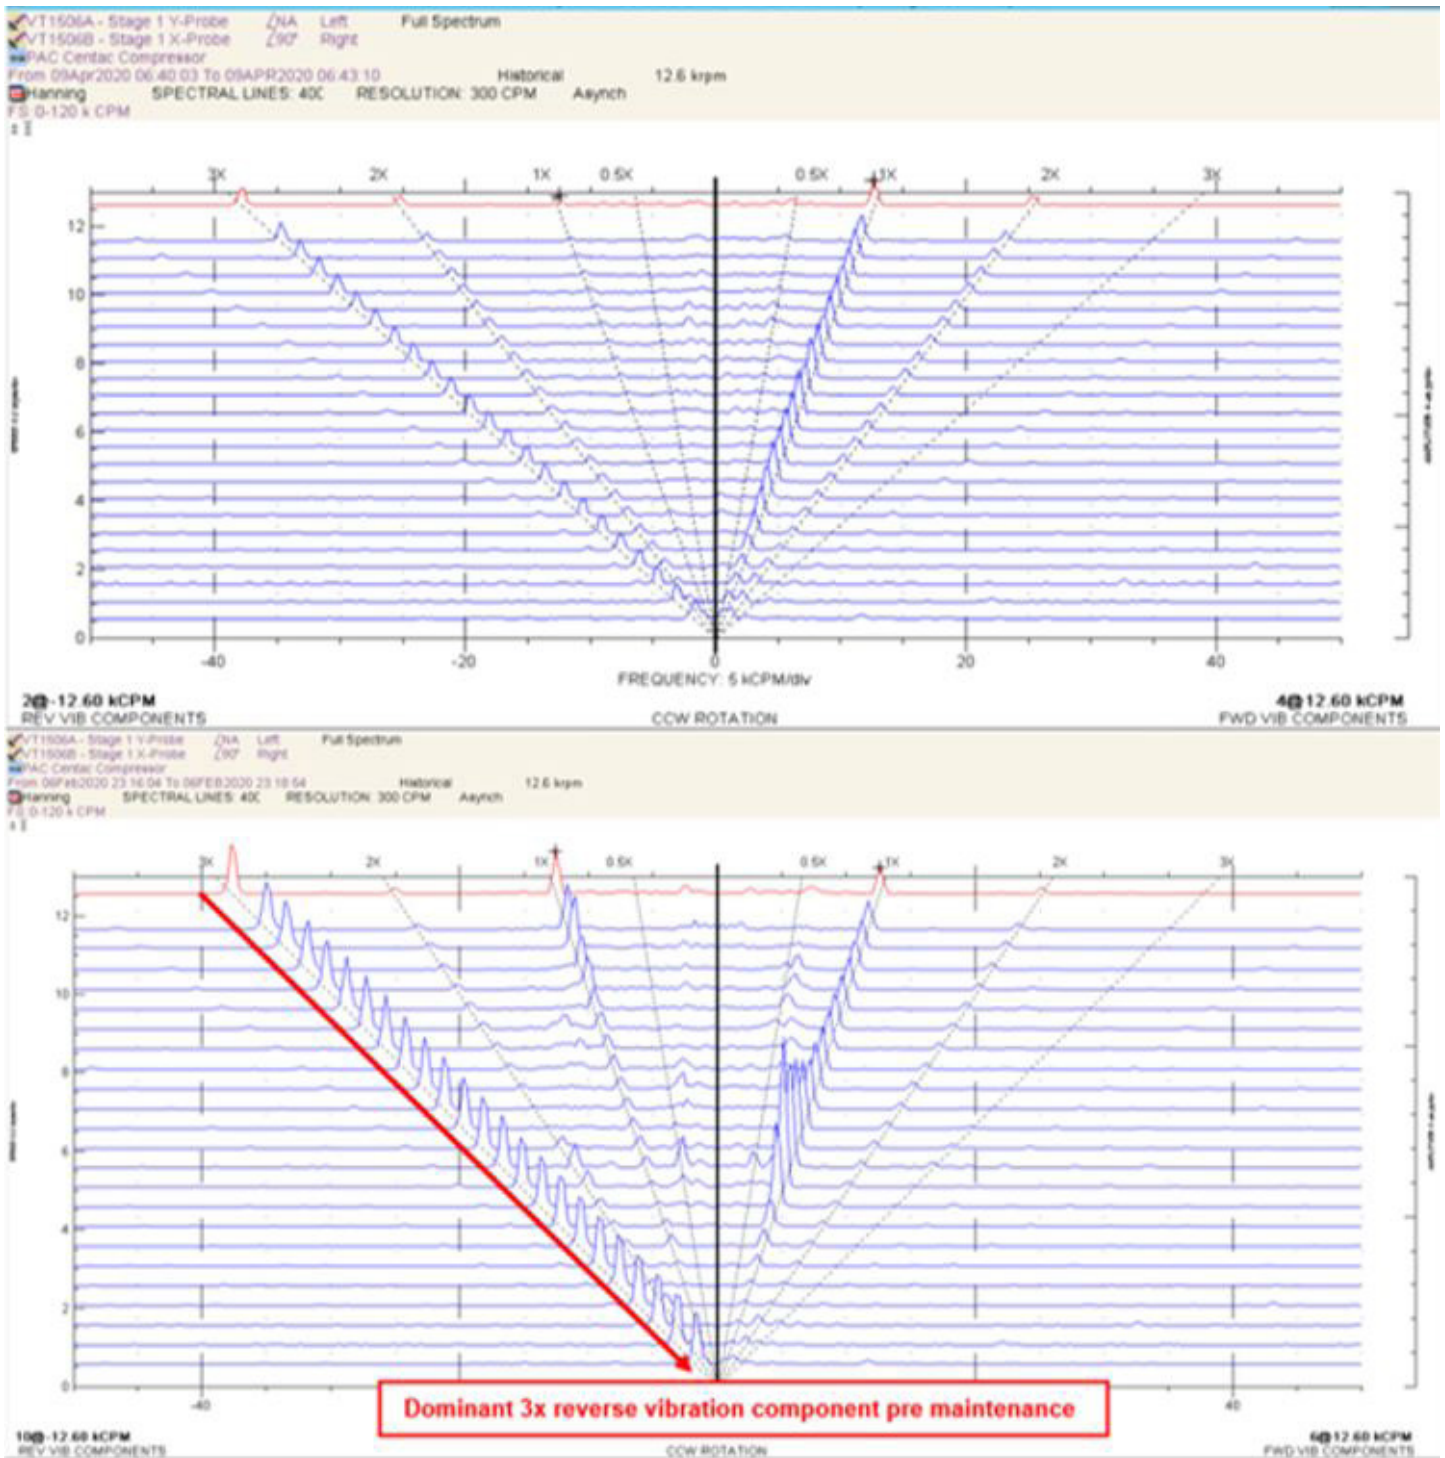
Post the repair, full spectrum asynchronous cascade and direct orbit plots verified a reduction in 1x synchronous forward vibration amplitudes during steady state operation as well as during transient events (transitioning of the 1st/translational balance resonance), as shown in Figures 10 and 11.

Figure 10: Full spectrum cascade plots. Pre-maintenance – bottom and post-maintenance–top

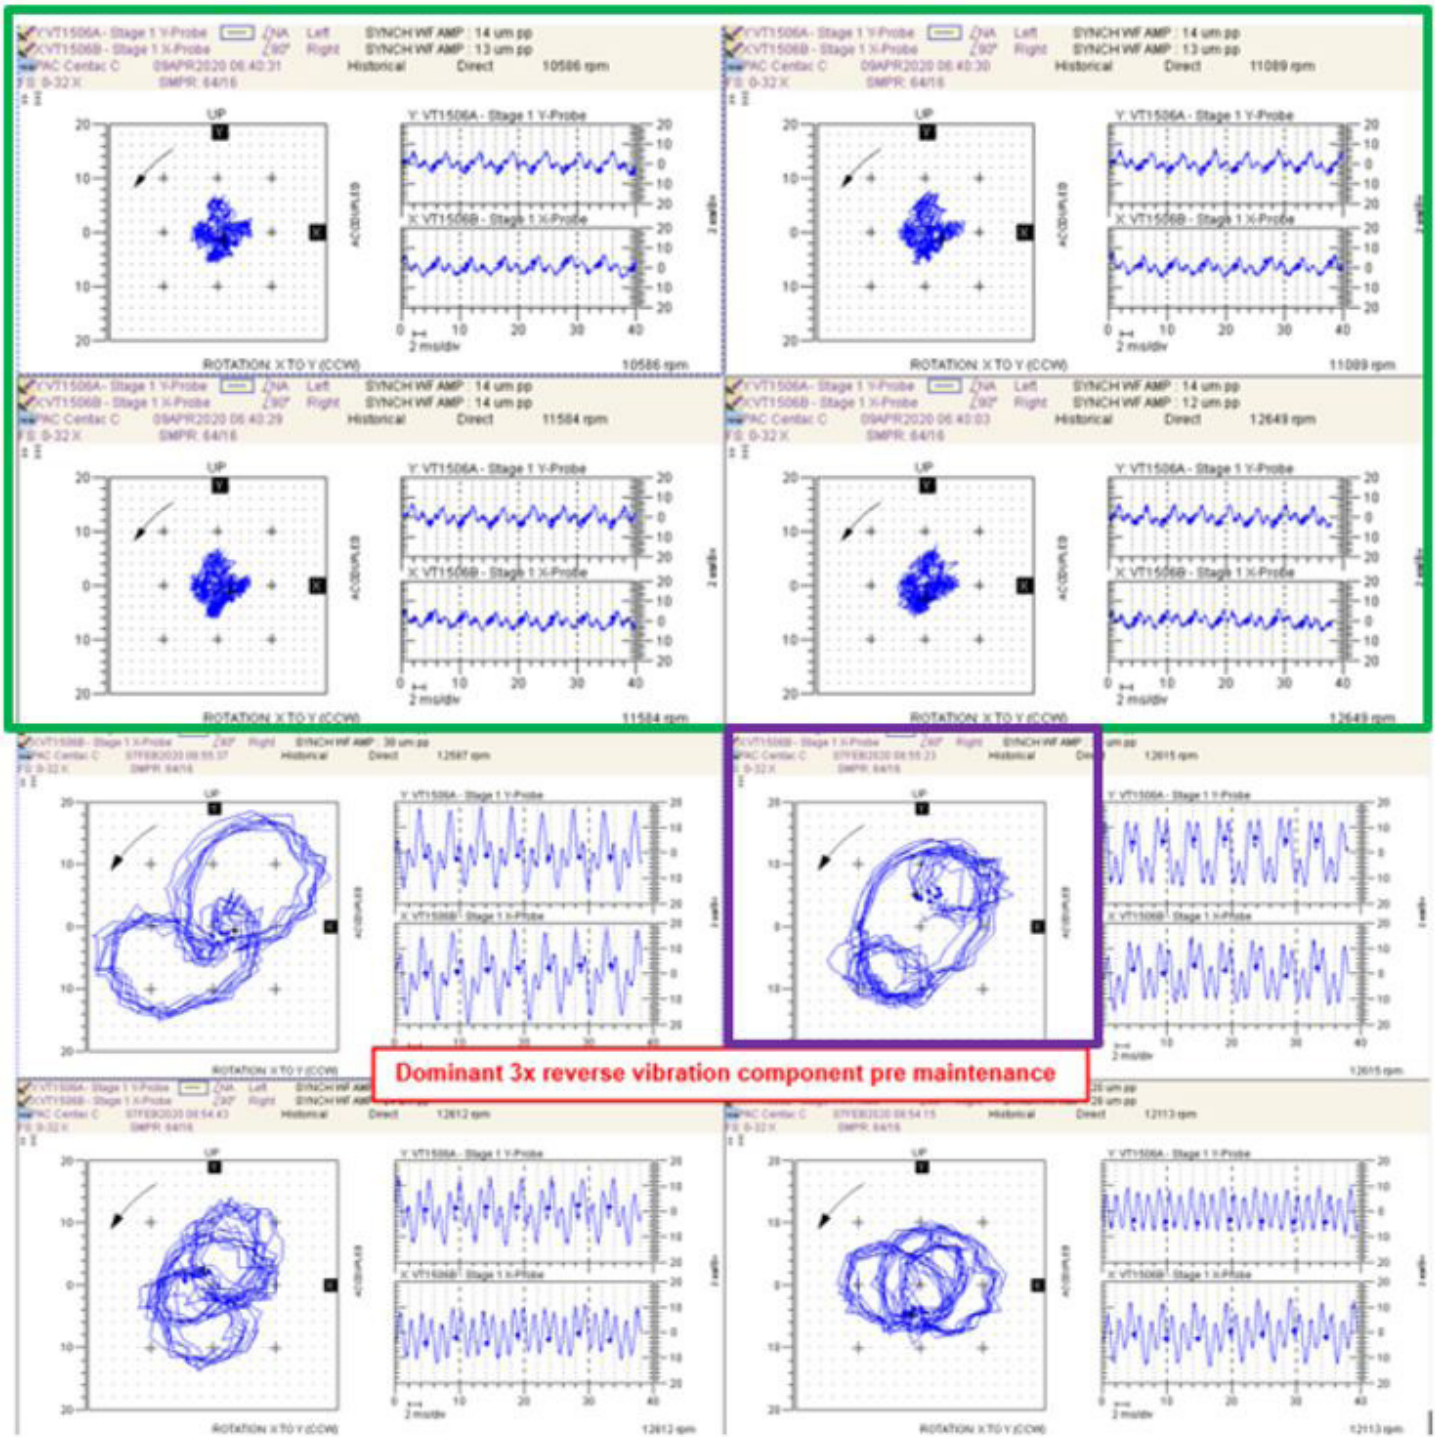
Post the repair the -3x reverse vibration component vibration remains with constant amplitudes measured in the region of 3 μm pp during each shutdown event. This indicates that the -3x vibration component is a characteristic of this design of Compressor rotor (P3 polygon shaped journal). It should be noted that there remains no 3x forward vibration whatsoever.

Figure 11: Orbit plots. Pre-maintenance – bottom and post-maintenance–top.
