Orbit Magazine

Throwback Thursday :: Mechanical Degradation

MECHANICAL DEGRADATION DUE TO ELECTROSTATIC SHAFT VOLTAGE DISCHARGE

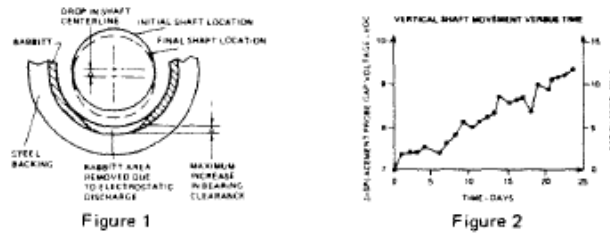
Figure 1 depicts a typical case where the journal has moved downward into the bearing. Identification of this position change can only be achieved by the variation in proximity probe DC Gap Voltage. This malfunction can occur radially or axially; and mutually perpendicular probes at each journal combined with axial position probes is mandatory. The Electrostatic voltage can traverse couplings and Gear Boxes, so the actual failure is often removed from the generating source. Therefore, it is essential to maintain accurate trend records of the DC Gap Voltage on all probes (e.g. Figure 2).

In Figure 2, note that a 12 Mil change in vertical position occurs during a 24 day period. If the bearing has a 15 Mil Babbitt thickness, the unit must be shut down for bearing replacement prior to Journal damage.

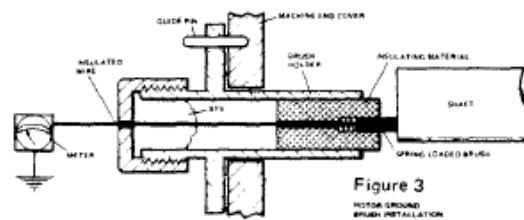
Figure 3 shows a grounding brush installed on several units with excellent success. The brush material can be a soft carbon, or a wire bristle brush. These points should be considered during installation of a rotor ground system:

1. Locate the brush at a point of low running velocity to minimize brush wear.
2. Meter the ground wire to verify if the brush is operational.
3. Insulate the brush from the brush holder and the machine casing.
4. Install the brush in a holder that can be changed on the run.
5. The assembly should be sealed to retard oil leaks.
6. Install no more than two brushes on a machinery train. Too many brushes may initiate ground loops between brushes.
