Case study: Norway

PRIME Technology Platform delivers critical metal milling solution in North Sea well

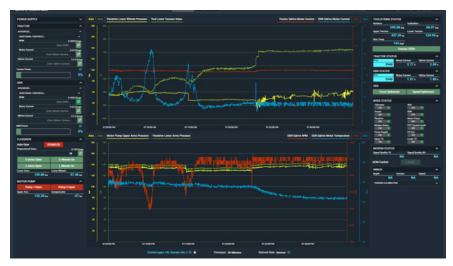
PRIME real-time surface read out data available during the operation

The operation was planned meticulously and executed leveraging the breadth of instrumentation and real-time data available throughout, enabling replication of the shop tests. This enhanced the visibility and handling of milling parameters allowing fine-tuned, seamless adjustments to be made during the operation, and a high understanding of milling progress. The **PRIME Technology Platform** also allowed continual rotation to occur, even when switching the tractor from driven to free rolling mode – this enabling effective back reaming to be done hence minimizing the chance of jamming. The **PrecisionStroker** tool was also added to the e-line toolstring as a contingency, enabling overpull above that available from safe e-line pull if/as required. The milling operation was completed successfully, and subsequent plug deployment and several perforation runs undertaken without issues when running through the milled flapper in both directions. This light, precise and highly effective solution solved the problem with unprecedented precision and control, minimizing risk and enabling well performance without the need of a costly sidetrack operation.
