Case study: Norway

Efficient single run – multi ball seat PRIME Milling operation

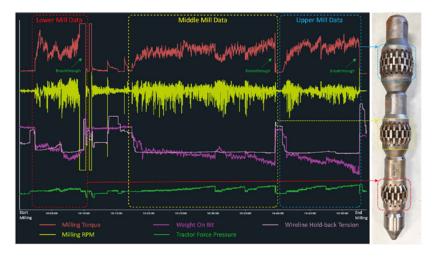
Critical tool parameters captured in real-time during the testing provided clarity and understanding of the milling sequence of each ball seat, with mill engagement and breakthrough of each mill clearly determined from the multitude of toolstring data curves available.

Typical indications of milling progress seen via surface readout are user-increased weigh-on-bit resulting in increased milling torque and reduced milling rpm; and increased downhole wireline tension as the tool mills further into the ball seat.

Example log data taken from a pre-job test done at the onshore engineering facility
